November 28, 2018

RE: Pillottown Park Addition

23818 SHORTLY ROAD, GEORGETOWN, DE

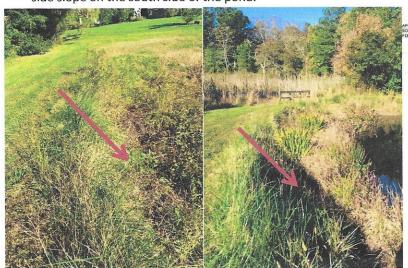
The District noted sloughing/erosion of the pond side slopes.
 The buffer is doing its job in holding the slopes at this time,
 however, you may want to plan for re-establishing the 3:1
 side slope on the south side of the pond.
